Architectural Transformations of Residential Buildings in Rural Areas of the Lublin Region

Jerzy Bański¹, Monika Wesołowska²

doi:10.5618/arch.2012.v1.n2.8 || Received: 26-08-2012, Accepted: 06-09-2012, Available online: 11-09-2012

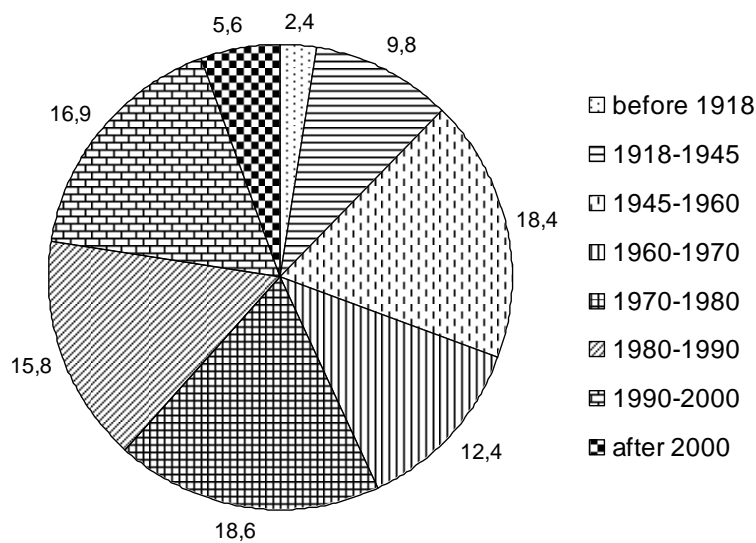
Fig. 2. Age structure of homes in the analyzed villages (Source: Own elaboration based on conducted field research).

While the buildings in the villages included in the studied are very diverse in terms of age, their age structure is rather consistent save for the oldest and newest constructions. The bulk of the buildings was erected in the periods spanning from 1945 to 1960 and 1970 to 1980 (Fig. 2). The first period was focused on the reconstruction of rural estates that had been damaged or destroyed during the war, which saw two separate fronts sweeping through the Lublin region. Farmers constituted the most numerous group of investors (60%) in this stage (**Table 1**). A boom in the agricultural sector, farmers being exempted from compulsory delivery of agricultural products, improved access to agricultural machinery and equipment as well as synthetic fertilizers all coincided so that in the following decade, farmers were still the primary investors in construction in the Lublin province's countryside. However, the advancing urbanization and industrialization of the country implied a significant outflow of people from the village to the city and a rise in the number of employees holding down two jobs (so-called *farmers-workers*). These processes seriously undermined and compromised building activity.

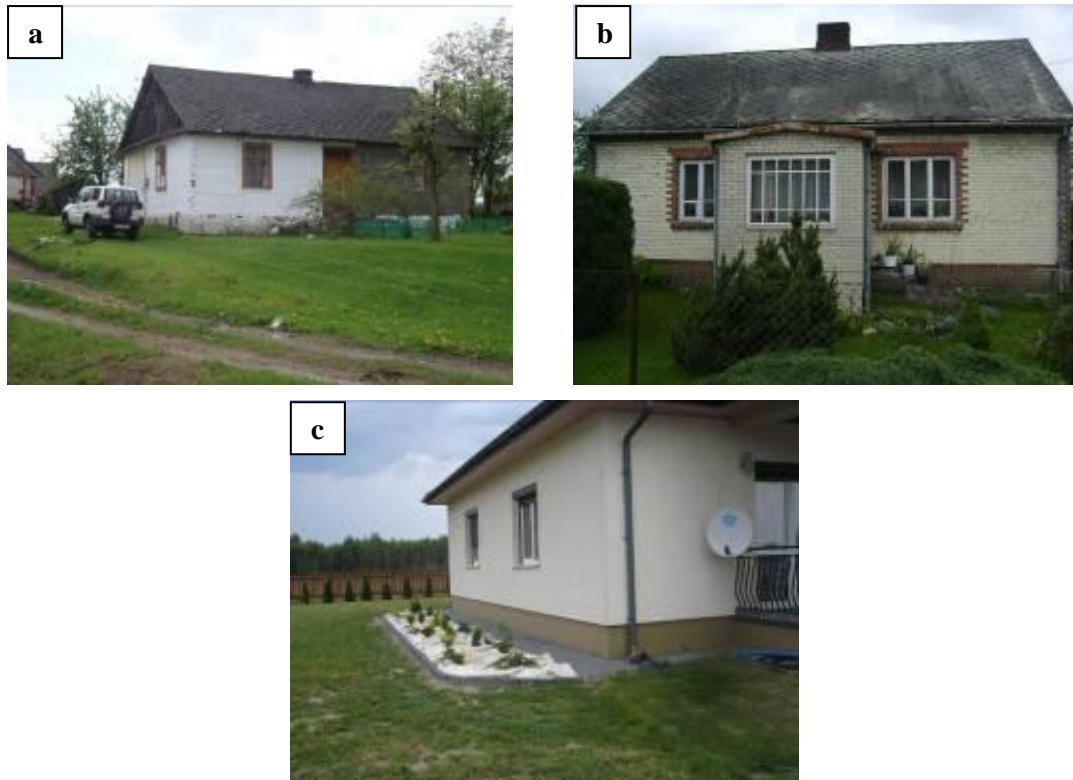
Photo 1. Building material for wall bases: a-stone, b-brick, c-decorative plaster (Source: author’s photographs).

wall base and the height of the base itself changed throughout the years. In buildings dating from before 1945, rock fragments and rock-derived composites available in the vicinity were often used for the wall base (**Photo 1a, Table 2**). Clay mixed with water was the main aggregate. Subsequent periods gradually abandoned the use of rock-derived resources, substituting them for brick and cement blocks (CMUs). Modern wall bases focus on enhancing the aesthetic quality of buildings, which are frequently reinforced with plaster and painted or adorned with decorative stone (**Photo 1**).

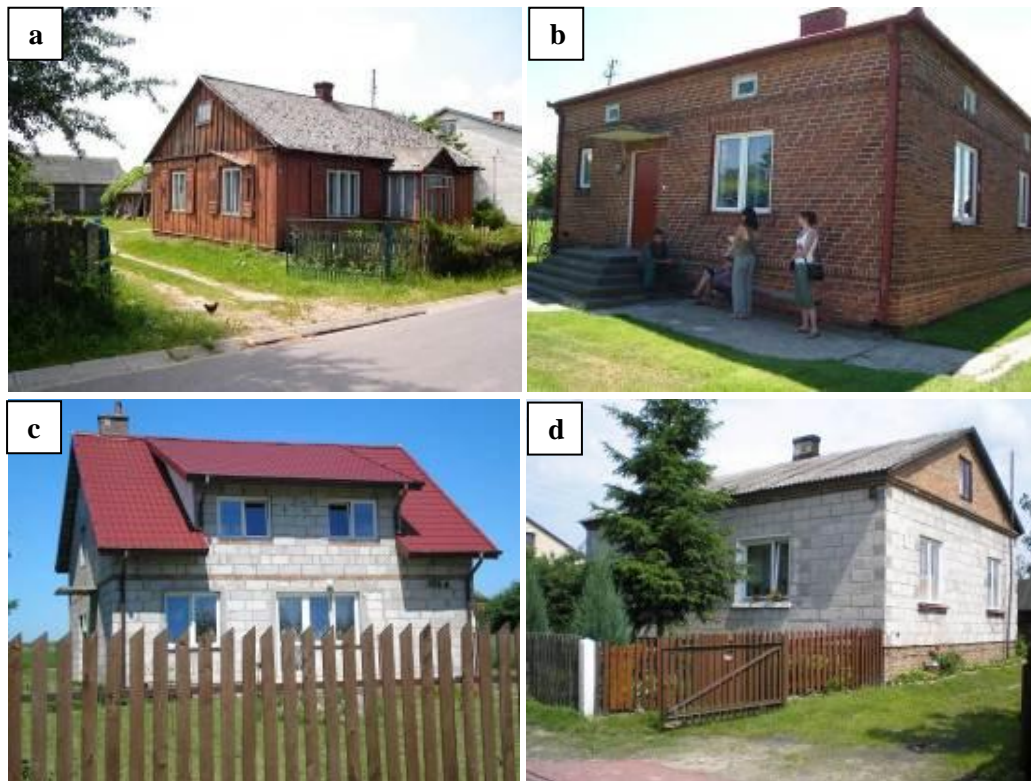
Photo 2. Building material for building walls: a-wood, b-brick, c-CMU, d-mixed (Source: author's photographs).

The building material of the walls is one of the key physical features of all houses. The oldest residential buildings relied on wood as their main building material (Table 3). The wooden country house was first raised in the late Middle Ages and has not undergone any significant development since. On a local level, one preferred construction material used for walls was wood with a mix of stone or brick. Wooden houses typically took the form of log cabins with interlocked logs at the ends. The pine logs were locked together in the “swallow’s tail” style (Polish corners); alternatively, the round logs were interlocked in a saddle notch. Buildings had half-

A gradual change in preferred building materials took place after the Second World War. The use of wood diminished as brick and CMUs were on the rise. The coming and diffusion of fire-proof materials was both a signal and a harbinger of progress in the country. The 1960s in particular saw a confident move away from wood, replaced by brick and the CMU as the primary building material. Finally, the walls of contemporary, modern-day buildings are built with CMUs and assorted materials.

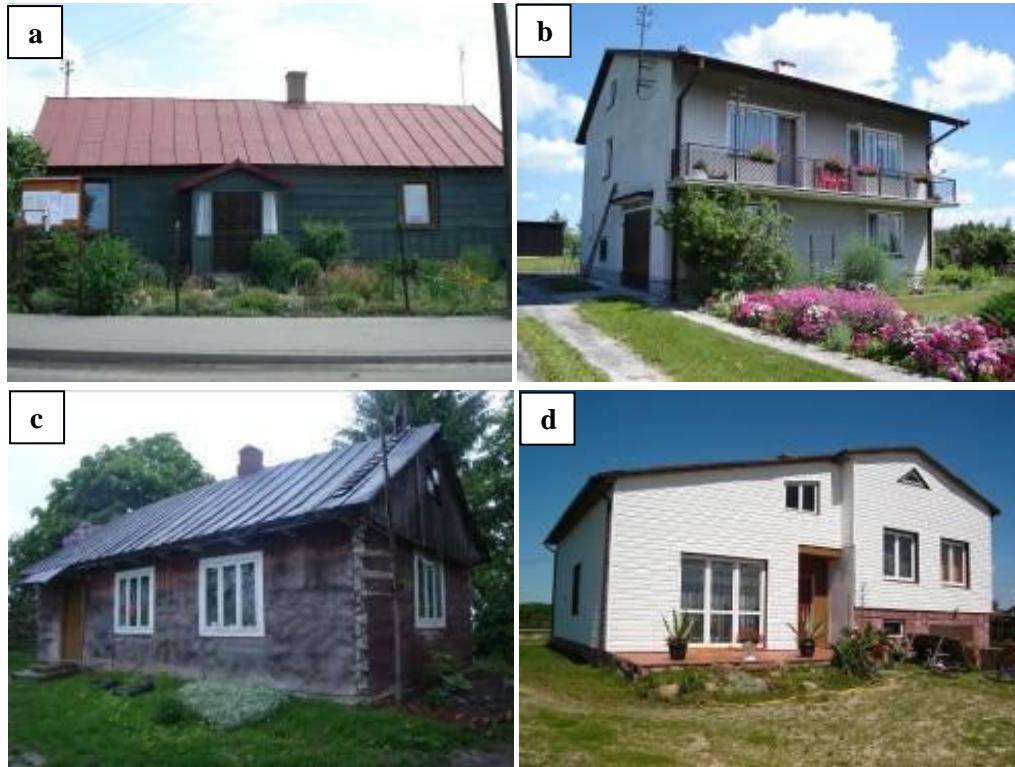
Photo 3. Wall cladding in houses: a-coating, b-plasterwork, c-tar paper, d-siding (Source: author's photographs).

In the villages included in the study, cladding, or the covering of a structure with another material, is applied to a major part of the walls of houses and their adjoining infrastructure. Cladding or mortaring is done with the purpose of sealing and protecting walls from the elements, conserving them and elevating the aesthetic beauty of the building. In the oldest buildings, the cracks between the logs were filled with clay or straw. The most commonly encountered type of cladding is plasterwork and coating (**Photo 3**). Older houses are first paneled, then coated with paint. The paneling is layered and constitutes a kind of isolation against low temperatures, while the paint conserves the wood and increases the aesthetic qualities of the house. Until the 1960s, buildings were commonly topped with tar paper for waterproofing, and this was later blanché with lime.

In later years, plastering entered into common use, either applied smooth or textured and sprayed. The plaster used was characterized by a very limited selection of colors. Today, the outside walls of houses are covered with colored acrylic plaster. In turn, another new and novel kind of cladding mixes plaster with other building materials. Elements of ceramic tiling, natural architectural stone or glazed tiling are used to finish parts of the façades of buildings threatened by humidity (foundations, outside staircases, terraces). Recent years have also seen a rise in popularity of outside covering made of plastic and synthetics, or siding (**Photo 3d**). This comprises

insulated covering that most frequently imitates horizontal or vertical boards. In most cases, siding comes in shades of white and beige.

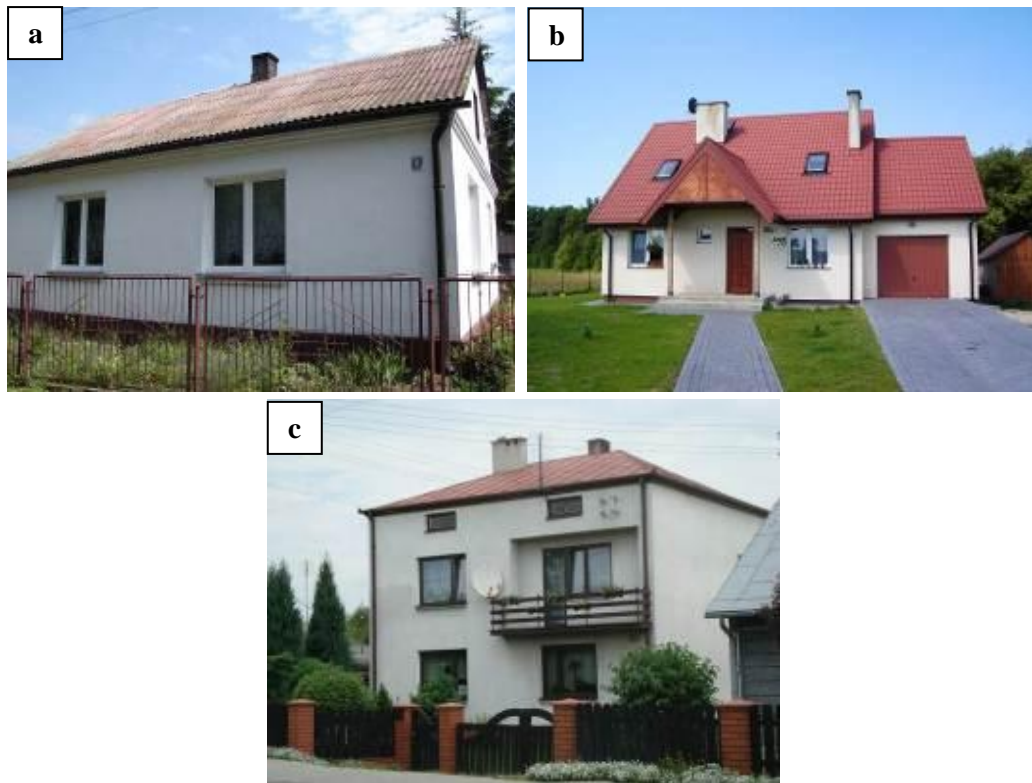
Photo 4. Examples of houses: a-one-storey, b-with functional loft, c-two-storey (Source: author's photographs).

3.3 Architectural Profile of Houses. The buildings in the villages this study encompasses are, for the most part, one-storey houses (**Table 6**), with a distinct correlation between the number of floors and the professional category the owner belongs to. Farmers and farmer-workers comprise the largest group of homeowners.

The first two-storey houses were built in the country in the 1960s on the wave of the rise in household income, primarily among artisans and white-collar workers. Two-storey houses are considerably larger than traditional houses; oftentimes, they exceed the real needs and financial

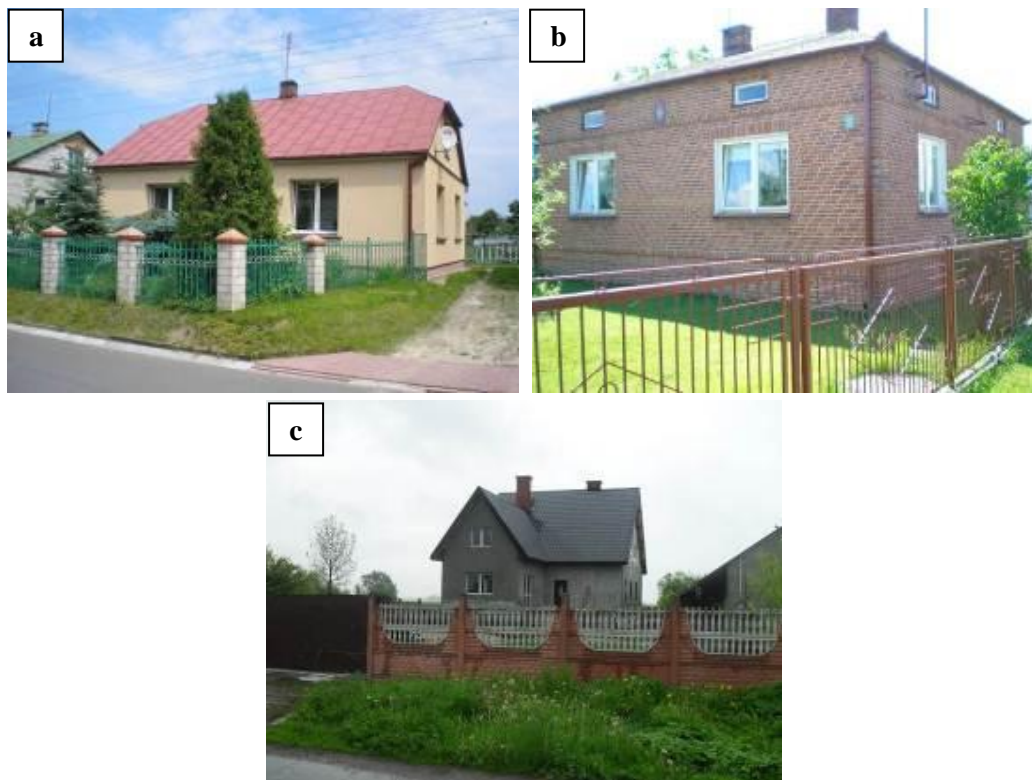
Photo 5. Shapes of houses: a-rectangle, b-square, c-combined (Source: author’s photographs).

Houses with rectangular floor plans were built until the end of the 1960s (**Photo 3**). The following decade brought a surge in square floor plans inspired by urban models that reached rural areas as well as by the standardization of projects. These new currents changed the face of rural Poland. Flat-roofed brick "boxes" peppered the Polish countryside, upsetting the traditional landscape that was the norm hitherto.

After 1980, investors returned to projects with rectangular floor plans; still, the difference between the size of the longer and the shorter side isn't very significant, generally not exceeding 1-2 m. Houses with this shape account for almost 60% of all buildings constructed between 1980 and 1990. In the present day, an increasing number of residential buildings begin to use alternative polygonal shapes in

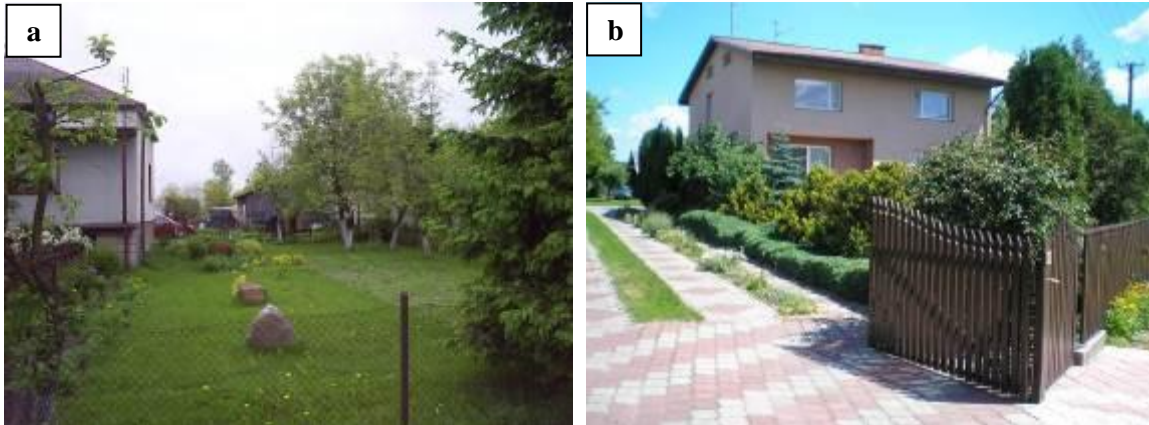
Photo 6. Use of land surrounding residential buildings: a-old houses, b-new houses (Source: author's photographs).

3.4 Surroundings of Residential Buildings. The use of the area immediately surrounding the residential building (e.g. stonework on sidewalks, driveways, gardens) is an essential component contributing to the general aesthetic allure of a home. Throughout the years, along with the transformation of the architecture of buildings and building materials, the way the area adjacent to the main building was used also changed, notably in the nature of the green areas close to the house. Decorative plant and tree species in particular became more diversified with the passage of time.

The research results allow us to state that the surroundings of residential buildings is in a constant state of transformation. The garden, which in the past has had purely practical uses (as an orchard or a vegetable garden), plays an increasingly decorative role or is intended for rest. A similar change has been observed in the purpose of fencing. Fences were previously used primarily as a means of preventing farm animals from escaping outside the limits of the property. Today, fences are rather considered as a kind of barrier providing much-needed isolation from
